# Car-Check

Volvo  
V70 Kombi

# VEHICLE INSPECTION REPORT

Comprehensive Technical Assessment & History

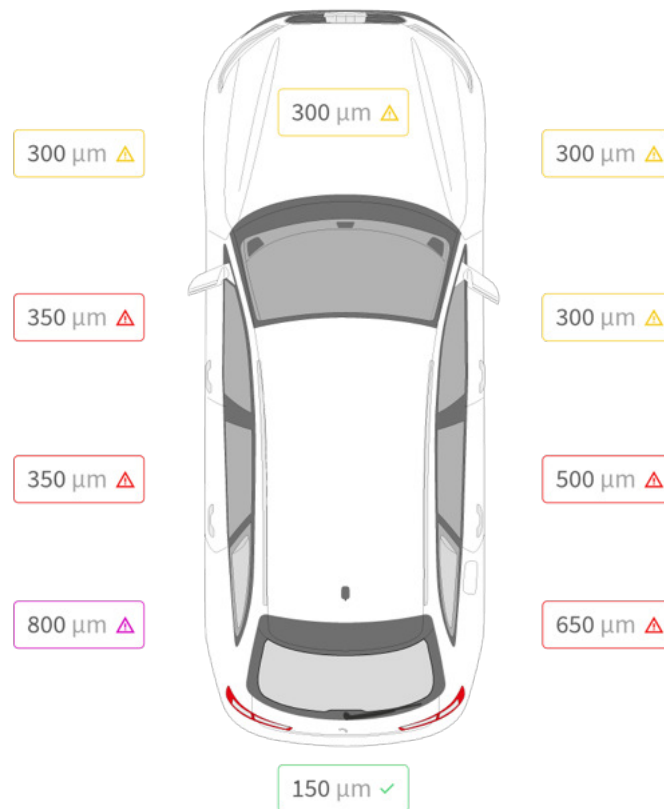
## Paint Thickness

| Part | Messwerte (µm) |
|---|---|
| Fender left | 300 ⚠ |
| Bonnet | 300 ⚠ |
| Fender right | 300 ⚠ |
| Driver door | 350 ⚠ |
| Passenger door | 300 ⚠ |
| Rear door left | 350 ⚠ |
| Rear door right | 500 ⚠ |
| Rear side panel left | 800 ⚠ |
| Rear side panel right | 650 ⚠ |
| Trunk | 150 ✓ |

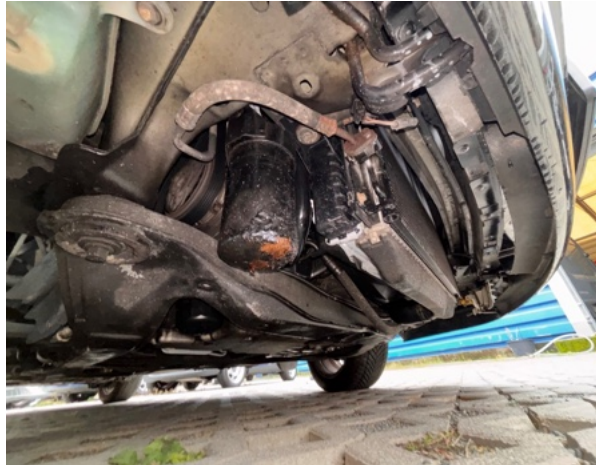
**Foto 40**

- Driver's seat heating functional
  - Passenger seat heating: connector unplugged, mounting loose
  - Air conditioning not working – compressor does not engage, compressor does not look ok (Foto 40), A/C "ON" button keeps blinking
  - Radio requires code to operate
  - Window switch on driver's door worn off
  - Windows, lights work
-

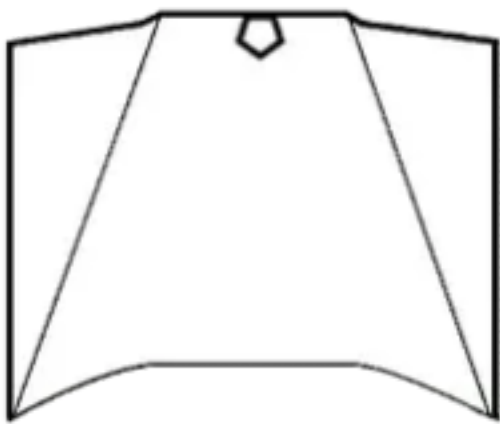
Hood

- 1. 100 µm
- 2. 120 µm
- 3. 110 µm
- 4. 110 µm
- 5. 100 µm
- 6. 130 µm
- 7. 110 µm
- 8. 120 µm

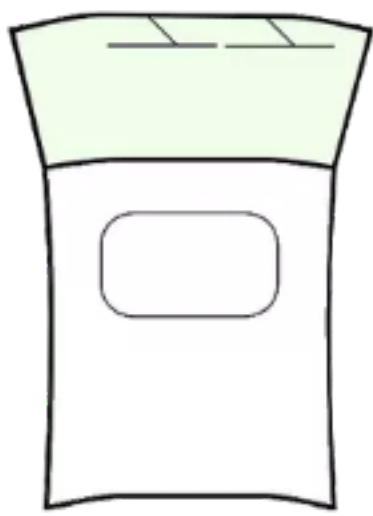
Roof

- 1. 70 µm
- 2. 90 µm
- 3. 60 µm
- 4. 80 µm
- 5. 90 µm
- 6. 90 µm
- 7. 70 µm
- 8. 70 µm

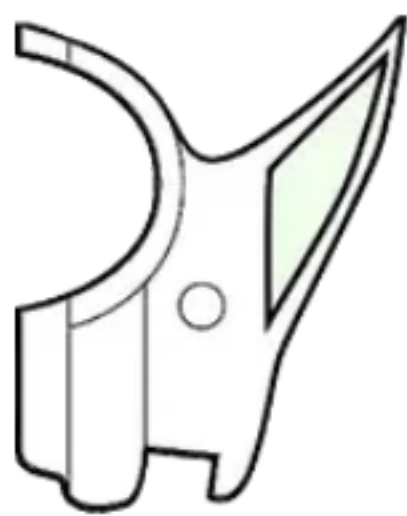
Left, rear fender

- 1. 100 µm
- 2. 90 µm
- 3. 90 µm
- 4. 90 µm
- 5. 80 µm

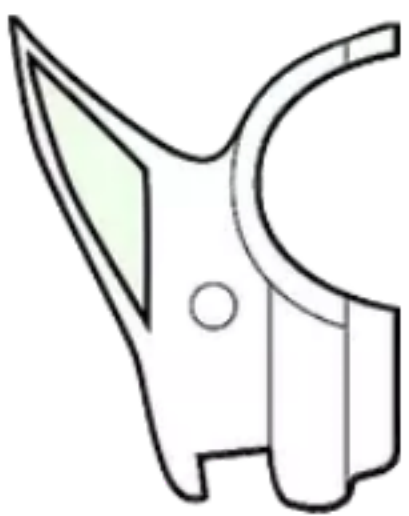
Right, rear fender

- **Paintwork condition:** The car retains original paint in the vast majority (factory values within the range of 80 – 110 µm).
- **Repainted elements:**
  - **Right side (rear door + fender):** Values 120 – 150 µm (double, cosmetic layer of paint, no signs of thick body filler/putty).
  - **Left rear wheel arch:** Localized touch-up/blend-in at the lower corner near the bumper.
- **Signs of corrosion:** Small spot of rust on the left front pillar (driver's side, near the edge with the roof) – requires anti-corrosion protection.

- 1. 130 µm
- 2. 120 µm
- 3. 150 µm
- 4. 150 µm
- 5. 220 µm
- 6. 90 µm
- 7. 160 µm
- 8. 180 µm
- 9. 340 µm
- 10. 190 µm
- 11. 230 µm

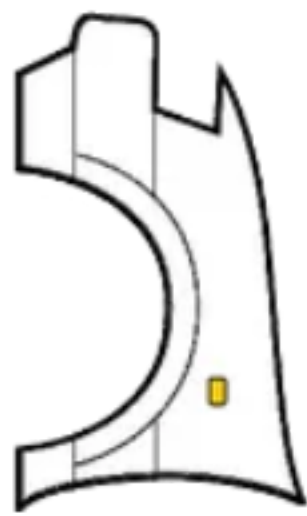
Left, front fender

- 1. 90 µm
- 2. 90 µm
- 3. 120 µm
- 4. 90 µm
- 5. 90 µm

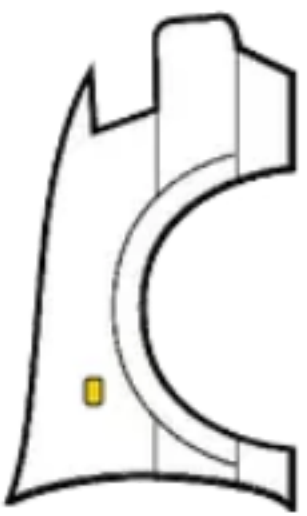
Right, front fender

- 1. 100 µm
- 2. 90 µm
- 3. 130 µm
- 4. 100 µm

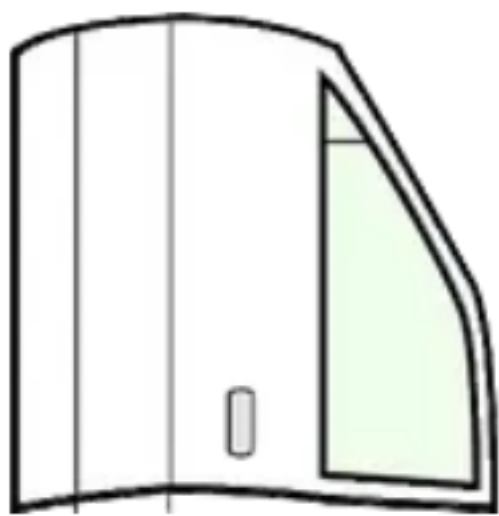
Left, front door

- 1. 90 µm
- 2. 90 µm
- 3. 90 µm
- 4. 100 µm
- 5. 110 µm
- 6. 130 µm

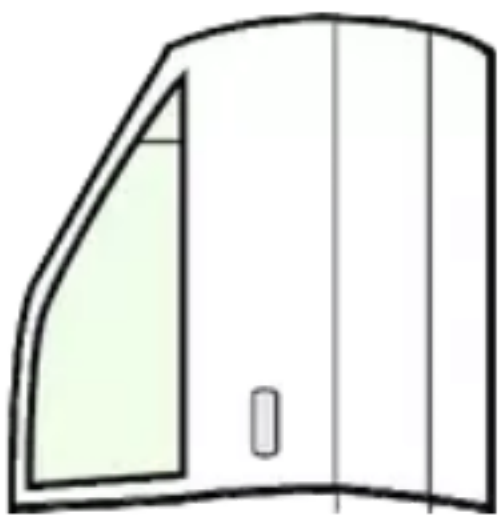
Right, front door

- 1. 300 µm
- 2. 220 µm
- 3. 230 µm
- 4. 190 µm
- 5. 150 µm
- 6. 130 µm

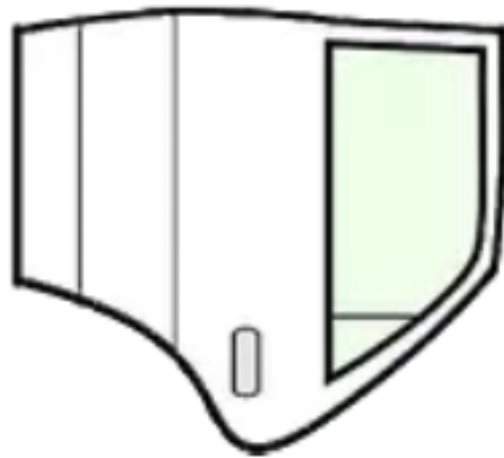
Left, rear door

- 1. 90 µm
- 2. 90 µm
- 3. 110 µm
- 4. 90 µm
- 5. 80 µm

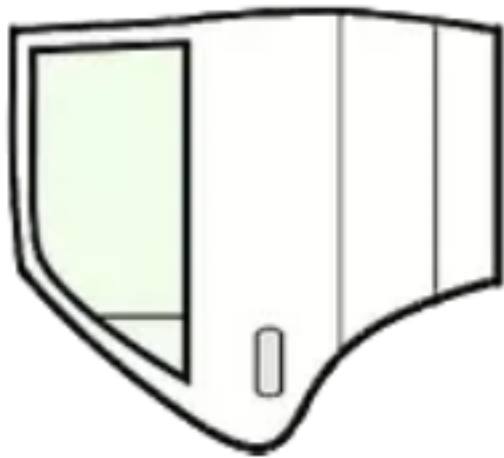
Right, rear door

- 1. 510 µm
- 2. 490 µm
- 3. 460 µm
- 4. 270 µm
- 5. 220 µm
- 6. 290 µm
- 7. 450 µm
- 8. 490 µm
- 9. 340 µm
- 10. 340 µm
- 11. 470 µm
- 12. 470 µm
- 13. 550 µm
- 14. 430 µm
- 15. 90 µm

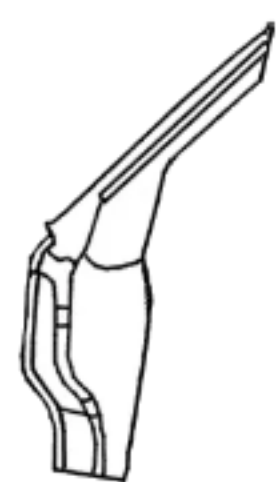
Left, a pillar

1. 30  $\mu\text{m}$

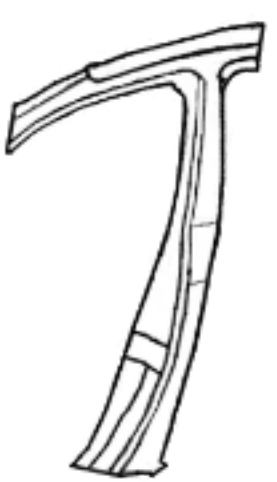
Left, b pillar

1. 50  $\mu\text{m}$   
2. 50  $\mu\text{m}$

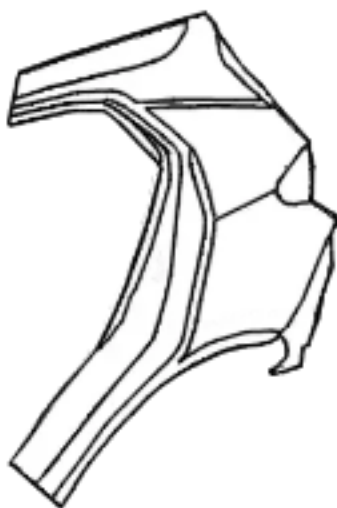
Left, c pillar

1. 50  $\mu\text{m}$   
2. 50  $\mu\text{m}$

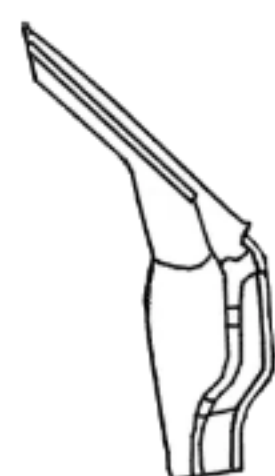
Right, a pillar

- 1. 50 µm
- 2. 40 µm

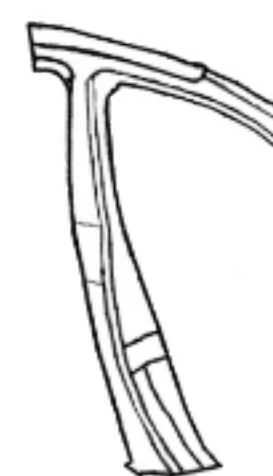
Right, b pillar

- 1. 90 µm
- 2. 60 µm
- 3. 70 µm
- 4. 50 µm
- 5. 80 µm

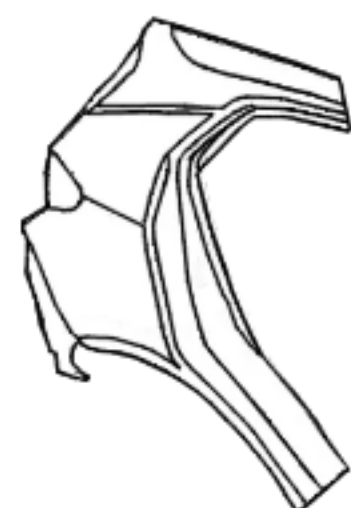
Right, c pillar

- 1. 100 µm
- 2. 120 µm
- 3. 70 µm
- 4. 100 µm
- 5. 60 µm
- 6. 100 µm
- 7. 90 µm
