# Car-Check

Volvo  
V70 Kombi

# VEHICLE INSPECTION REPORT

Comprehensive Technical Assessment & History

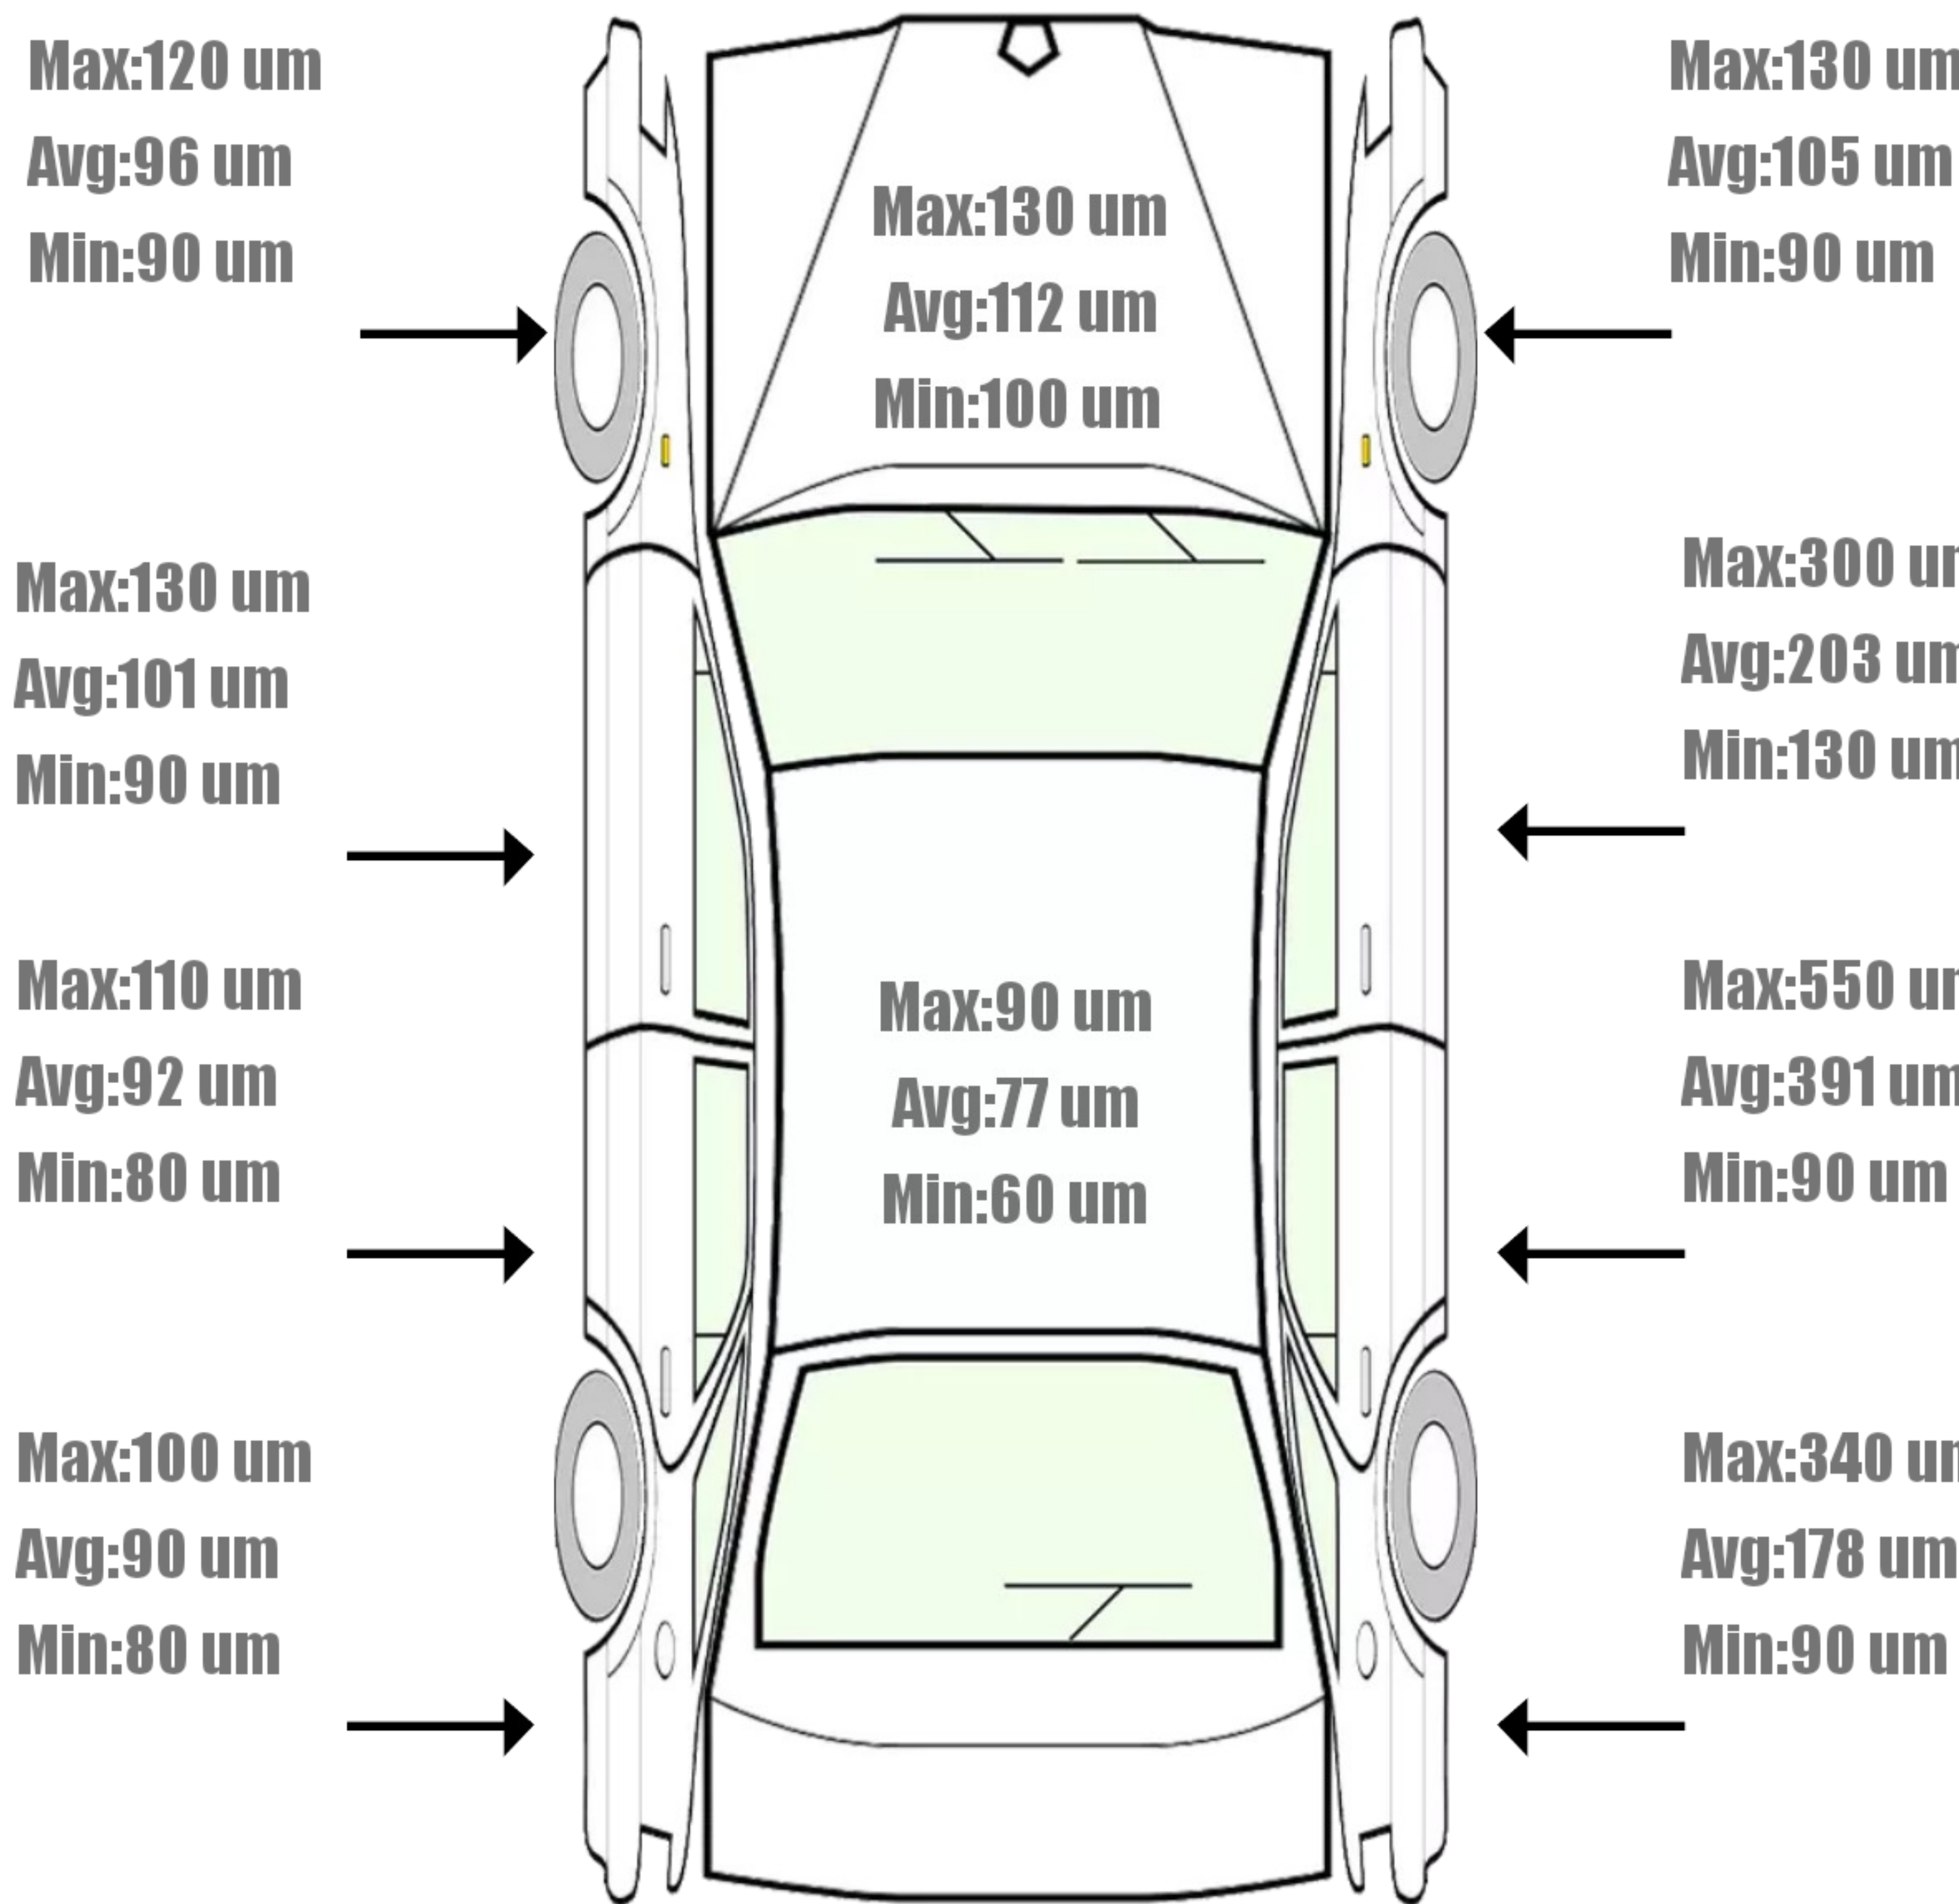
GRAPHIC PRESENTATION OF VARNISH ELEMENT MEASUREMENTS

- **Paintwork condition:** The car retains original paint in the vast majority (factory values within the range of 80 – 110 µm).
- **Repainted elements:**
  - **Right side (rear door + fender):** Values 120 – 150 µm (double, cosmetic layer of paint, no signs of thick body filler/putty).
  - **Left rear wheel arch:** Localized touch-up/blend-in at the lower corner near the bumper.
- **Signs of corrosion:** Small spot of rust on the left front pillar (driver's side, near the edge with the roof) – requires anti-corrosion protection.
